On October 20, 2021 I did a site visit to evaluate the condition of a residence located at 411 Lippincott Avenue in Riverton. I inspected the inside and the outside of the residence.

# UCC NEW JERSEY NOTICE OF UNSAFE STRUCTURE

## SITE VISIT REPORT

**Project:** 411 Lippincott Avenue, Riverton, NJ  
**WO#:** H13851-21  
**Report By:** Anthony Ercole, P.E.  
**Report Date:** November 16, 2021  
**Visit Date:** September 21, 2021  
**Time on Site:** 8:30 to 11:00 AM  
**Participants:** James Brandenberger (part time)

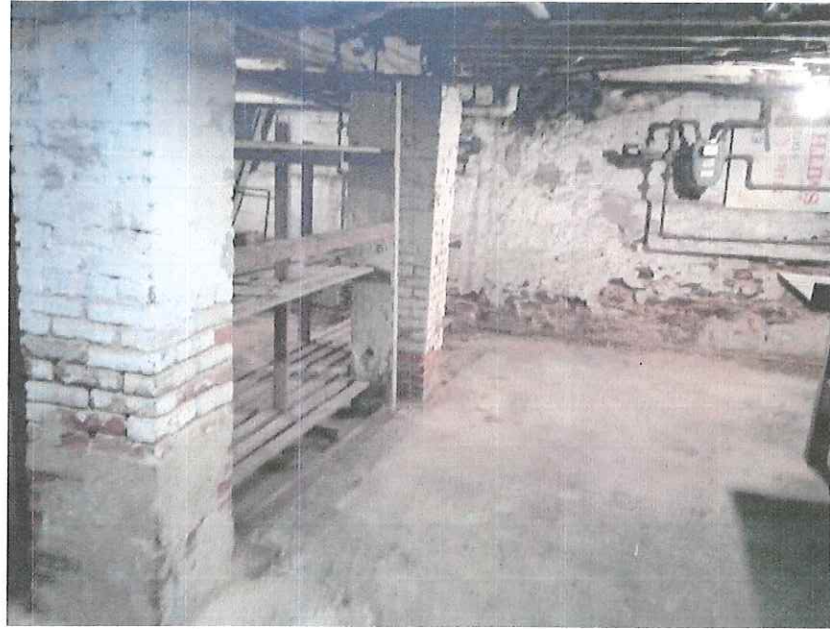
- The basement walls are in fair condition with only minor signs of cracking (Photograph #1). The basement shows signs of on-going water infiltration in several areas, as evidenced by the failing parging and deteriorated mortar joints on the walls.
- Shoring was installed in several locations throughout the basement (Photograph #2). Shoring in this type of application is generally added to correct sagging floors or reinforce the existing joists.
- Access into the crawl space from the basement was not possible, therefore we could not determine the condition of the porch framing and columns.

**Photograph #1 - Basement walls**

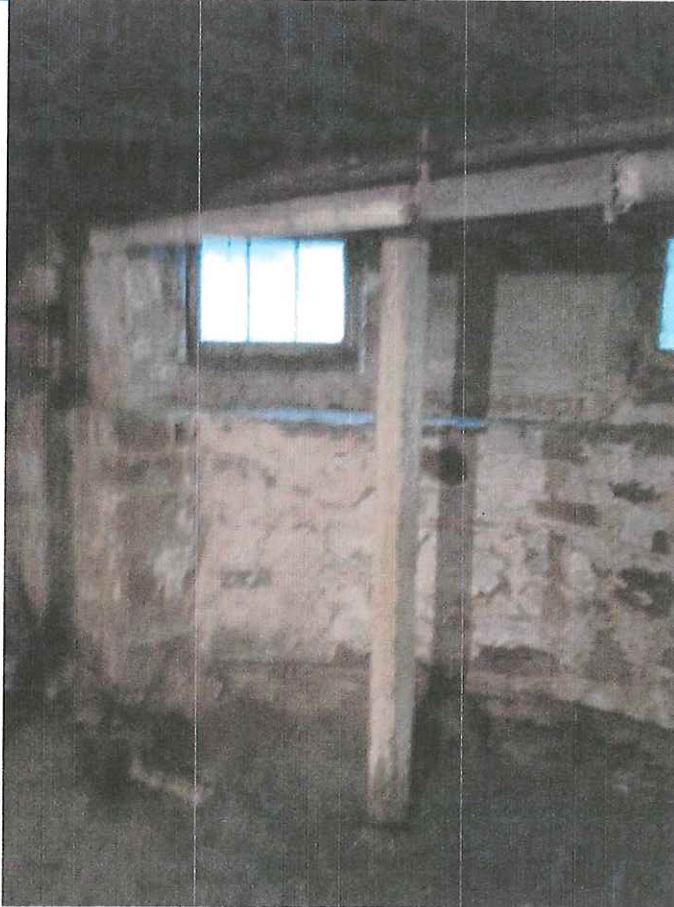
Photograph #2 - First floor framing - additional shores

5. The temporary shoring should be reviewed to determine if the shoring is adequate or should be replaced with permanent posts and footings. Reinforcement or replacement of the existing framing may also be necessary.
6. While the exterior brick work of the chimney appears to be in good condition, it is noticeably out of plumb. The chimney will likely require reconstruction.
7. The main stairway including the floor landings have settled, and sloping hand rails are noticeable at the floor levels. Removal of the existing plaster will be required to determine the cause(s) of the settlement.
8. The porch framing and columns are beyond repair and should be replaced in their entirety.
9. At the rear entrance, the foundation wall has disintegrated and will require reconstruction in localized areas.
10. A number of floor joists supporting the kitchen are decayed and will require replacement.

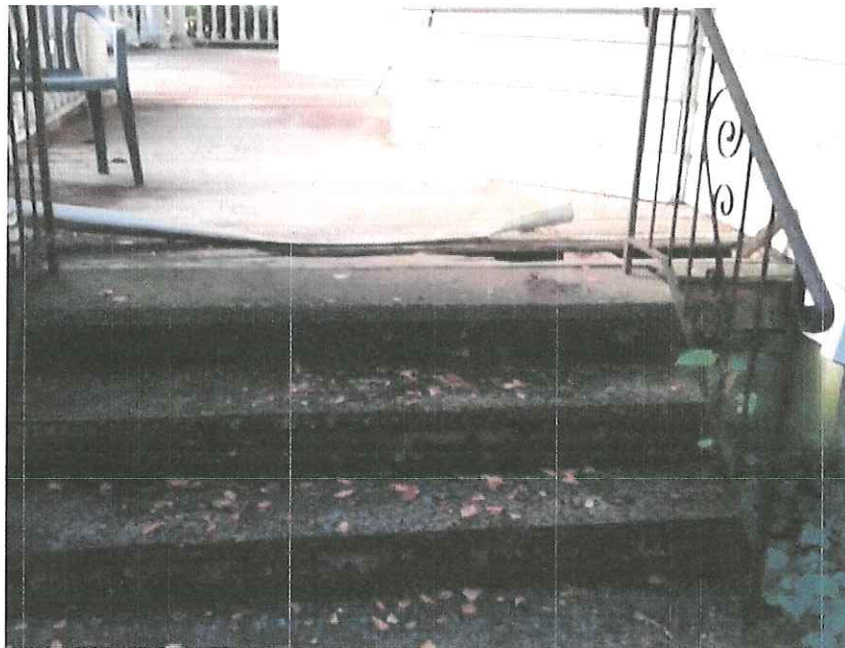
- The porch floor and supporting columns (Photograph #3 and Photograph #4) are in very poor structural condition. Decaying wood at the column bases and missing floor decking was visible in many locations. The eaves of the porch roof have several areas where the wood has completely rotted away (Photograph #5).

Photograph #3 - Porch floor and supporting columns

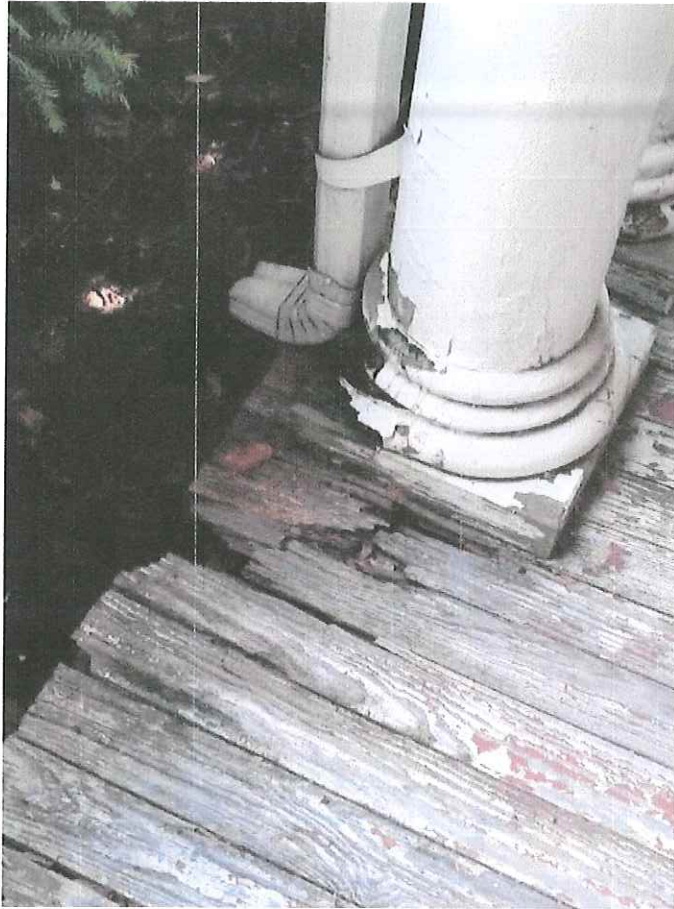
Photograph #4 – Porch floor and supporting columns

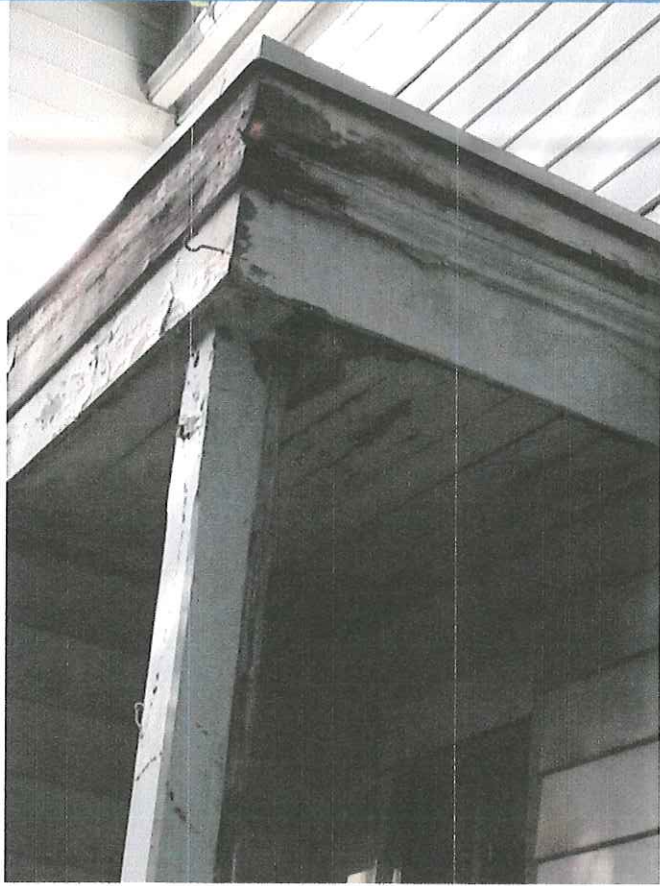
**Photograph #5 – Porch roof eave**

1. The floors are out of level and slope noticeably toward the exterior of the building. This behavior is frequently the result of decaying wood sills brought on by moisture in the foundation walls. Replacement of sections of the original wood sills may be required.
2. The full height vertical wall cracks in the rooms could also be related to the floor settlements. The repair would necessitate the removal of the existing wood lath and plaster and replacement.
3. Moisture has also damaged the window sills. The walls must be opened to determine the magnitude and extent of the required repair.
4. The exposed roof eaves in many areas are severely deteriorated and will require significant repair.

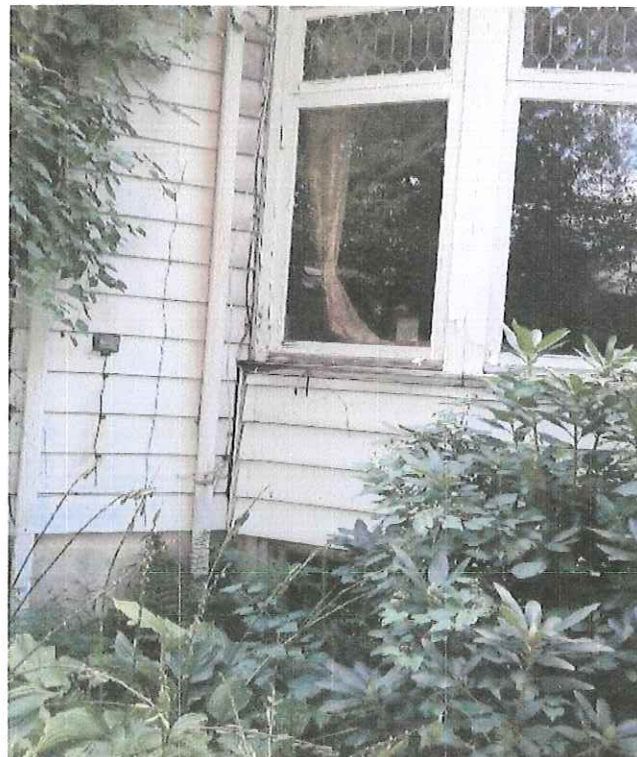
2. The sills at the bay windows (Photograph #6) on each side of the porch are in extremely poor condition. The wood sills are decayed and have settled making the windows inoperable.
3. Numerous full height vertical wall cracks were observed throughout the interior of the first floor especially at the interface between the bay windows and the main walls of the house (Photograph #7 and Photograph #8).
4. Cracks were observed in the walls and ceiling throughout the first floor.
5. Uneven floors and settlement of the floors were noted throughout the entire first floor.
6. Sections of the floor sheathing and floor framing were missing in the kitchen area (Photograph #9).

**Photograph #6 – Bay window sills**

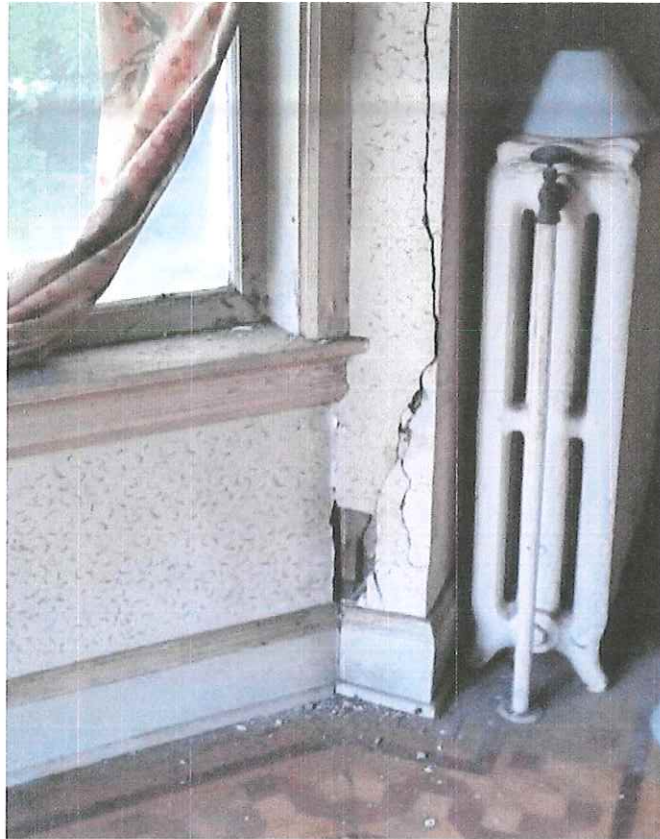
Photograph #7 – Interior first floor wall

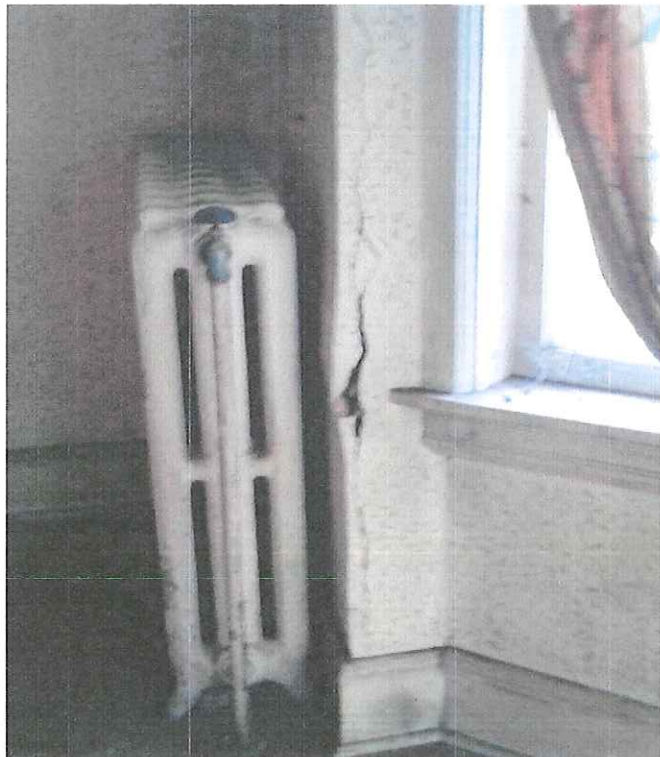
Photograph #8 – Interior bay window sills

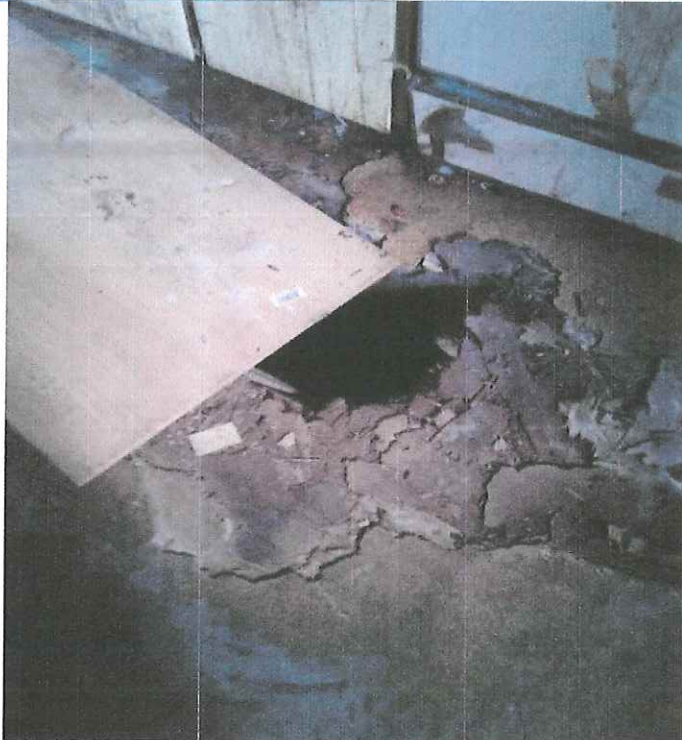
Photograph #9 – Missing floor framing – kitchen

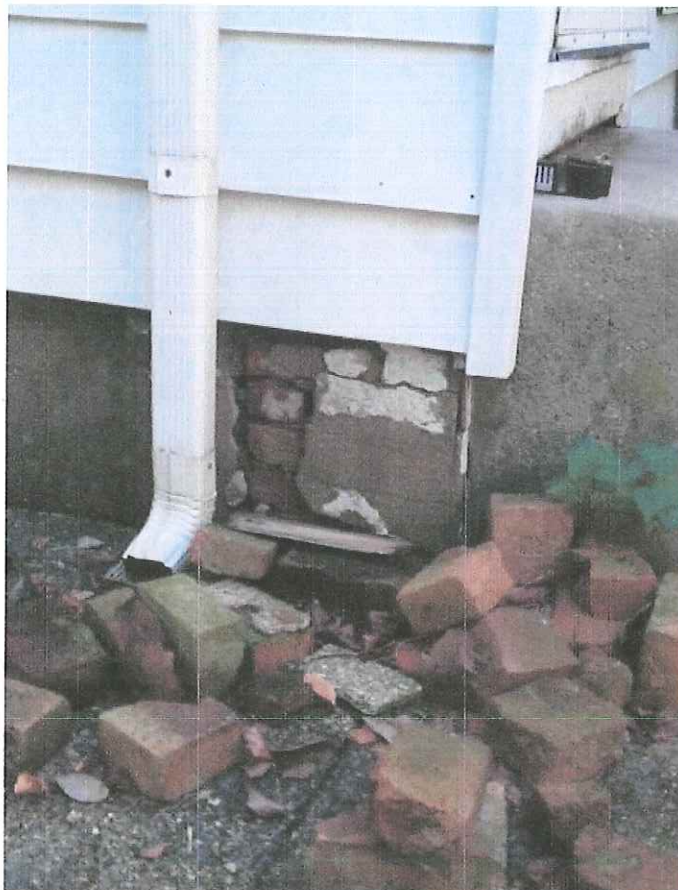
1. Distressed foundation conditions were noted at the rear corner of the building (Photograph #10). This included the cracking in the brick and parging, along with a loss of mortar from within the joints.
2. The chimney on the left side of the house appears to have moved away from the main structure (Photograph #16 and Photograph #17). Mr. Brandenberger noted that he measured the chimney to be out of plumb by as much as 12".
3. Rotting and decaying sections of the exterior eaves were observed in many locations.

Photograph #10 – Distressed foundation

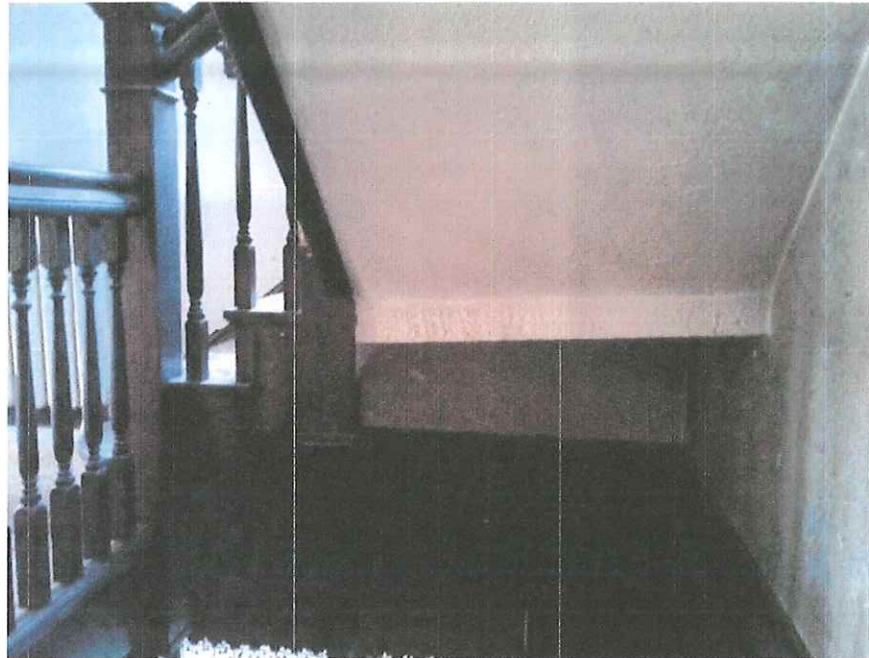
1. The stair connecting the first and second floors are noticeably sagging (Photograph #11).
2. Uneven floors and settlement of the floors were noted throughout the both floors. This condition was especially severe in the areas adjacent to the bay windows.
3. The sills at the bay windows have settled and the windows are inoperable (Photograph #12).
4. Many of the exterior sills and eaves are extremely decayed. (Photograph #13, Photograph #14 and Photograph #15).

**Photograph #11 – Stair deflection and settlement**

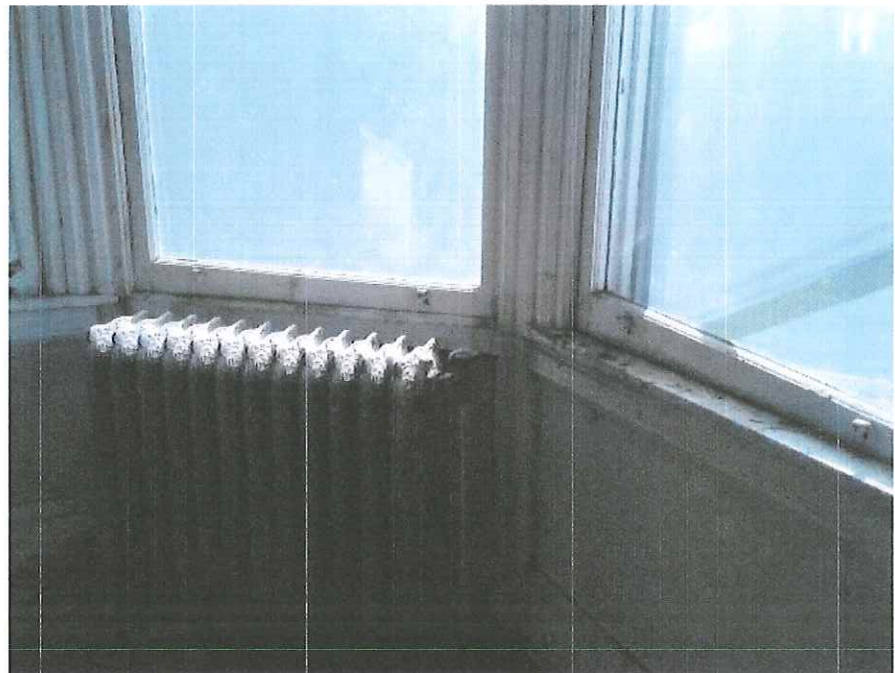
**Photograph #12 – Bay window sills**

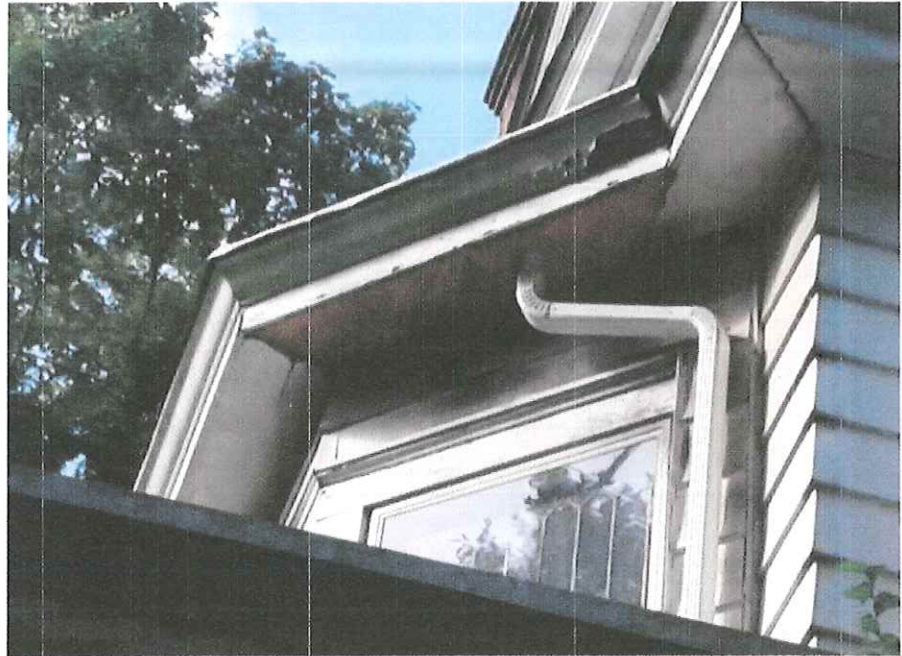
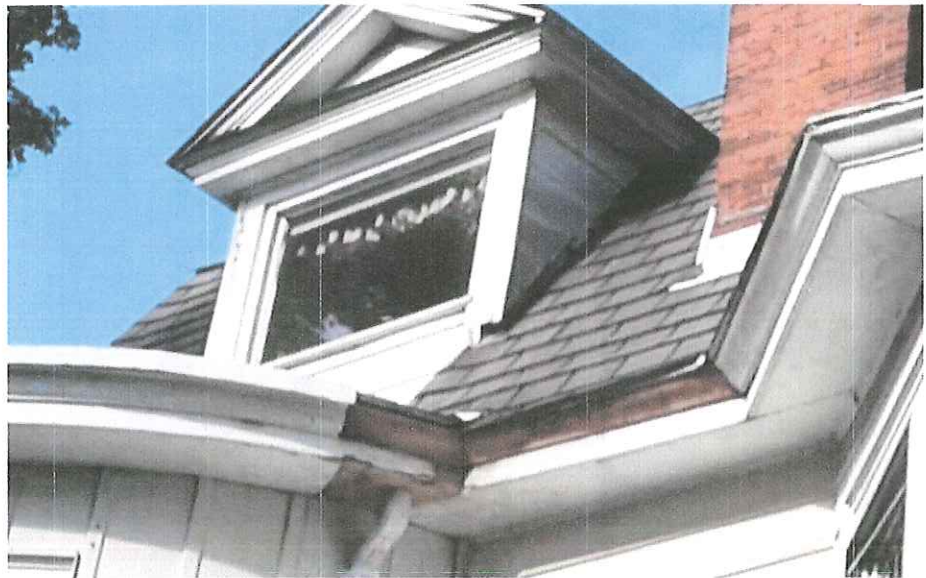
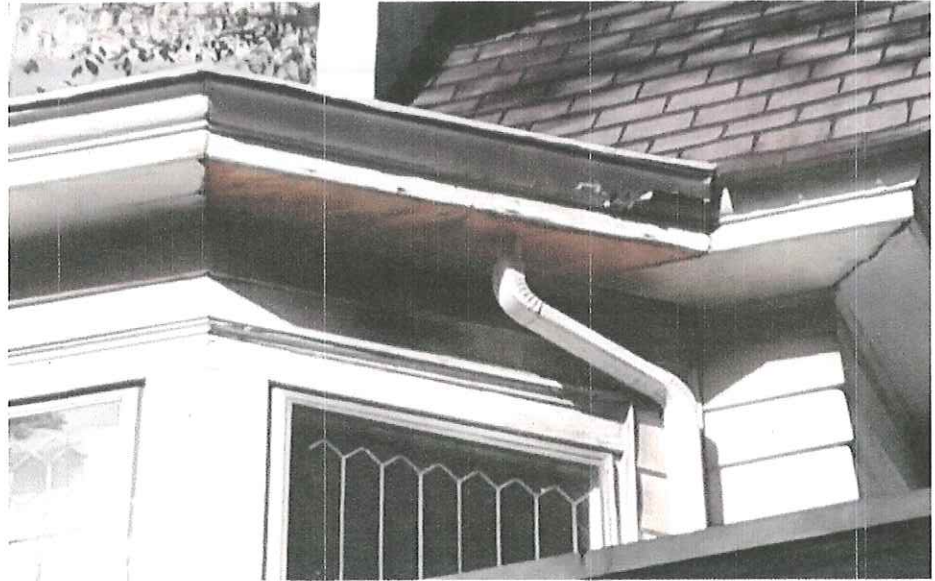
**Photograph #13 – Decayed eaves and sills**

**Photograph #14 – Decayed eaves and sills**

Photograph #15 – Decayed eaves and sills

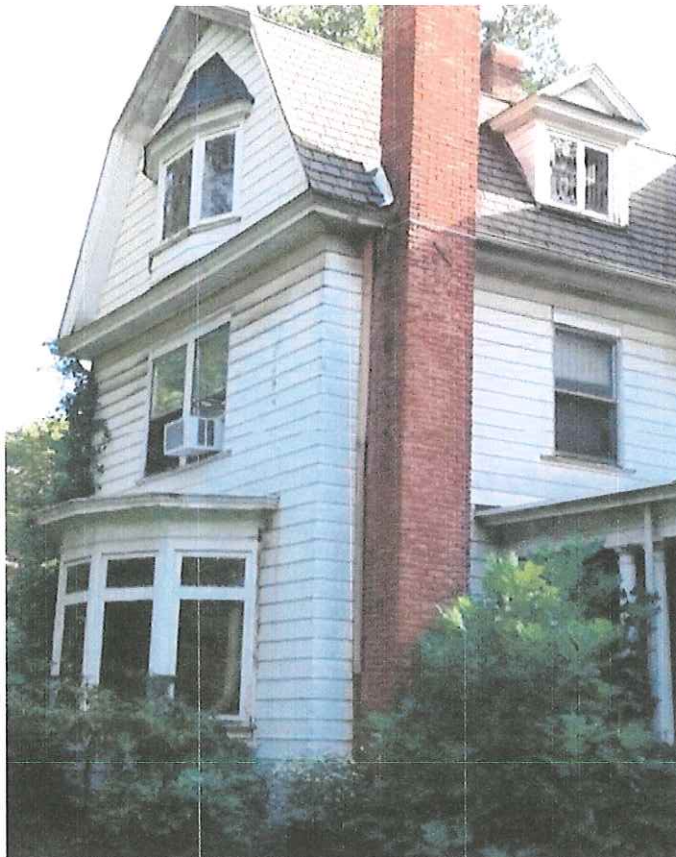
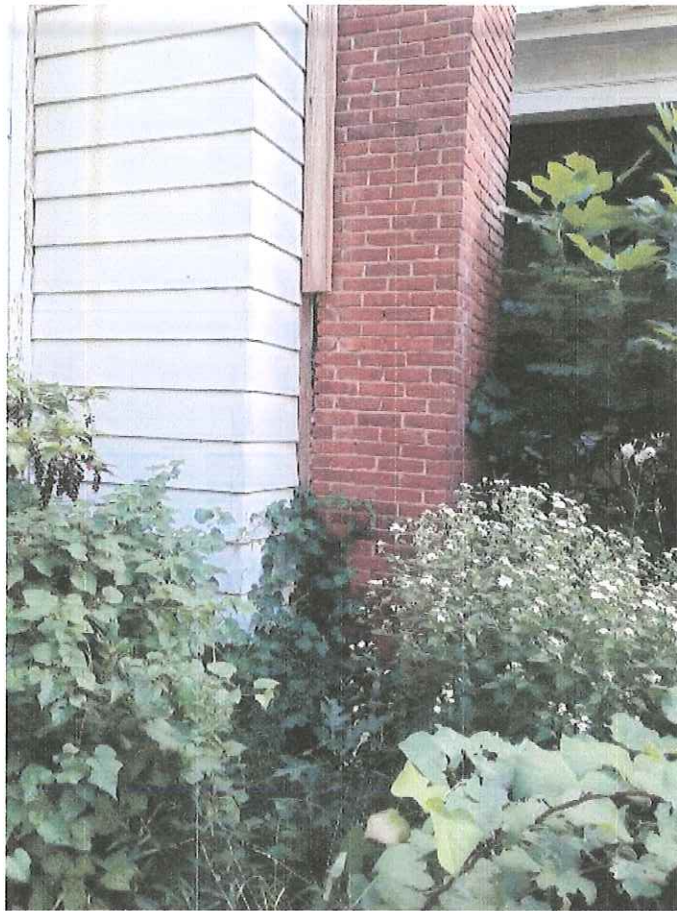
Photograph #16 – Chimney on left side of house

Photograph #17 – Chimney on left side of house
